Manhole Inspection Summary

Manhole # S09II2009MH

Insp Date: **7/10/06 11:34 AM**

Location Address: **6214 IVYMOUNT RD**

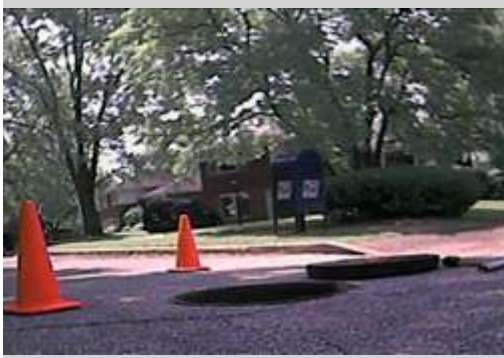
Location View

Comments **Cracks in pavement around manhole. May be a source of infiltration.**

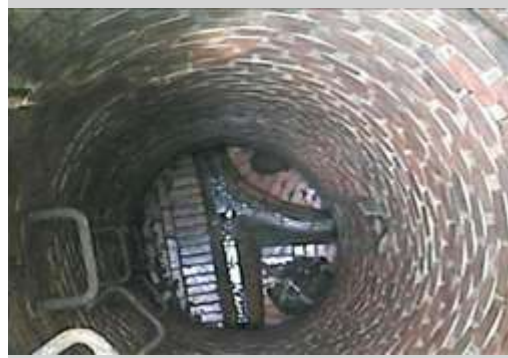
Top View

Bench debris. Corroded steps.

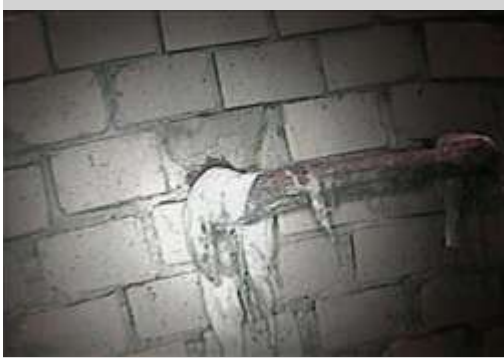
Defect

Evidence of surcharge, corroded step

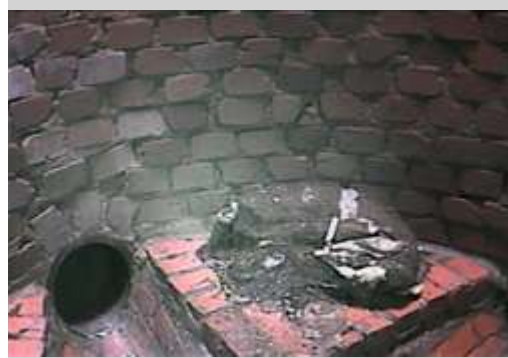
Defect

Bench debris.

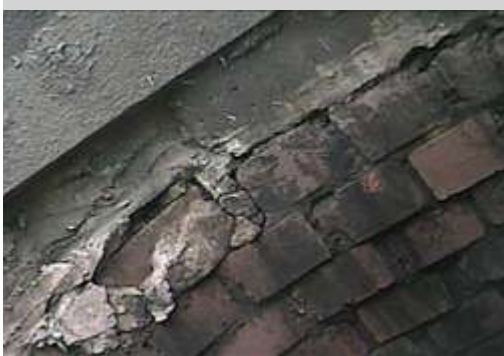
Defect

Frame leaks. Adjustment loose brick.
Adjustment infiltration.

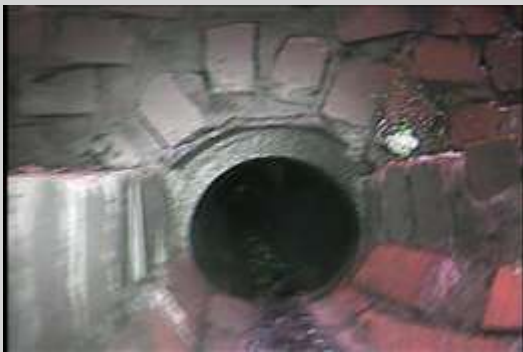
8 in. Circular Gravity Sewer Pipe Out @ 12 O'Clock

Invert Depth: **13.72** (ft.) Flow Characteristics: **Slow**

Infiltration: **None** Pipe Seal Cond: **Unknown**

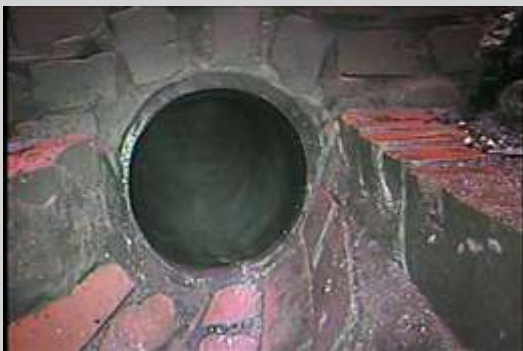
8 in. Circular Gravity Sewer Drop In @ 3 O'Clock

Invert Depth: **8.12** (ft.) Flow Characteristics: **Slow**

Drop: **Outside** Rod and Bar

Drop Condition: **Open**

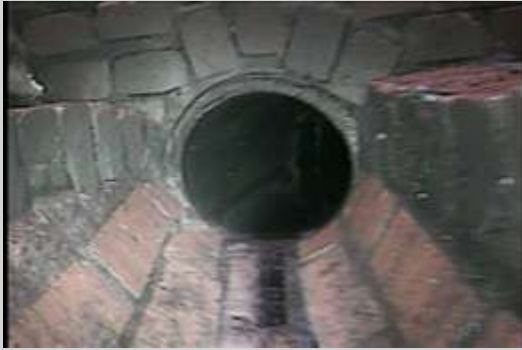
Pipe In @ 6 O'Clock

Invert Depth: **13.42** (ft.) Flow Characteristics: **Slow**

Infiltration: **None** Pipe Seal Cond: **Unknown**
